he MGF can soon show signs of slackness in the rear ebar bushes. Sloppy bushes can result in the car feeling unstable at the rear under braking. The remedy for his is to either replace the bushes completely or install ompliance washer.

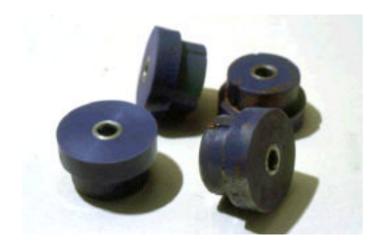
The original tie bar bushes

eplacement Polyflex tie bar bushes optained from IGFCentre Wolverhampton 01902 403045

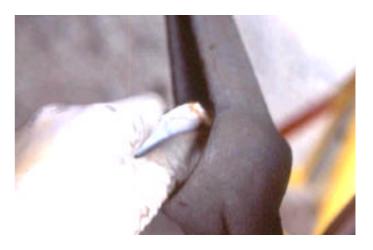
he 10mm bolt retaining the tiebar to the subframe is a ttle tricky. Access from underneath is very limited how-ver either a flat spanner or a small ratchet handle and ocket will remove this once a bit of brute force is pplied. The bolt is held in a captive nut so there is no leed for a second spanner.

with the two nuts removed the tiebar can be easily removed. Once removed inspect the seating surfaces and clean them as required with wire wool or a wire brusl to remove any corrosion
